Re: The Doe Run Company - Leadwood Mine Tailings Site Monthly Progress Report

Leadwood Mine Tailings Site
Leadwood, Missouri
Removal Action - Monthly Progress Report
Period: August 1, 2013 – August 31, 2013

This report details the findings of the inspection, and gives preliminary overviews of potential design options for the decant tower structure, as well as potential future investigative measures.

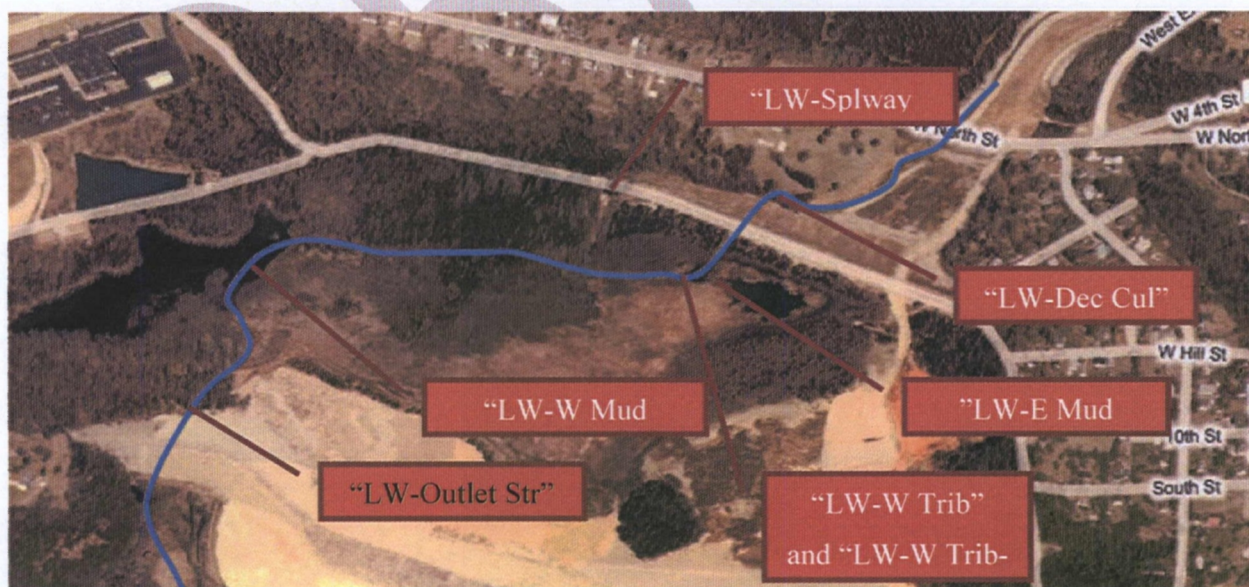
In addition to the aforementioned field observations, grab samples of water were acquired from the flows leading to the decant structure, the pools of water near the decant tower inlet, and the discharge from the decant tower culvert. These samples showed increased concentrations of metals following the conveyance of water through the decant structure, particularly with regards to lead and zinc. The results are displayed in Table 1 and the sampling locations are depicted in Figure 1. Because

Figure 1 – Sampling locations; "LW-Outlet Str" is upstream of all other sampling locations, while "LW-Dec Cul" is downstream of all other sampling locations
